BJM CORP ALL-TEST™ Case Study: Phase Unbalance 012002

Theme: Case Study – Phase Unbalance at Vermont Yankee Nuclear

Location: Vermont Yankee Nuclear Power Plant
Equipment: 50 HP, 3600 RPM, 480 Volt, Open Drip Proof, Cooling pump motor
Effected Systems: 500 MW Generator Bearing Cooling
Failure Cost: \$1,000,000
Savings: >\$1,000,000

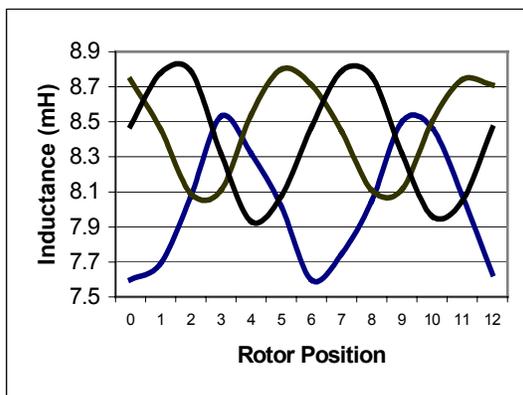
Figure 1: Rotor Test (Inductance)

An ALL-TEST III™ was used to determine the phase unbalance, with results of 000, -016 and -016 (% unbalance) phase to phase when the rotor was shifted to the peak unbalance on each phase. Two additional motors of the same model and similar serial numbers were selected for review and tested using both the ALL-TEST IV PRO™ 2000 and ALL-TEST III™. The resulting phase unbalances and rotor tests were evaluated (Figure 1 and Table 1 are examples of the common results):

The unbalance was found to be striking, and related to the unbalanced current, vibration and heating of the motor. Possibilities were explored ranging from power quality to test equipment calibration. All were satisfactory.

The motor manufacturer was contacted and noted that process changes were made at a particular location for larger concentric wound machines. In a motor of this size and speed, the first set of concentric coils (one phase) curls under the following phases, reducing the equipment's winding appearance and mechanical strength. In order to combat that issue, the manufacturer made a decision to significantly increase the size of the first set of coils in their automated process (first phase) that also happens to be the furthest from the rotor. This allows the coil ends to appear without having to make post-winding modifications to the coils. No dynamometer testing, full load testing, or otherwise was performed on the motor design other than an applied voltage impedance test that 'met design requirements.' Electrically, inductance is directly impacted by distance from the rotor, number of conductors and dimension of the coil. The motor manufacturing process improvement caused the unbalance.

Vermont Yankee Nuclear has now implemented a program to test all incoming critical electric motors prior to acceptance using a combination of the ALL-TEST III™ and ALL-TEST IV PRO™ 2000.
