## CASE STUDY:

### Fan Motor Test Reveals Damaged VFD, Prevents Safety Hazard and Process Downtime

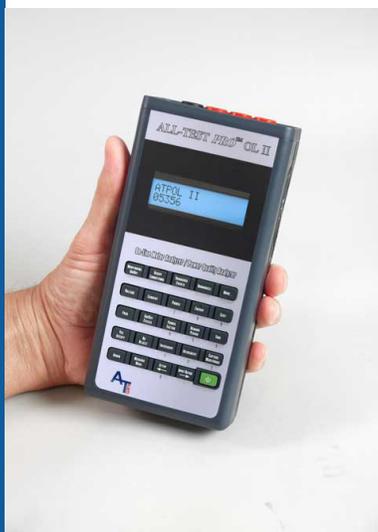
Figure 1. Measurements taken at the VFD input show an abnormal waveform. This waveform shows how the current coming into the VFD is unbalanced. For example, the straight lines from the 15 second mark to the 23 second mark are flat – which means the VFD is not receiving any current. This waveform is not normal for a healthy VFD (a normal waveform at VFD input should look like the waveform in Figure 3).

The fan is comprised of an impeller keyed directly to the motor shaft, which is controlled by a variable frequency drive (VFD). Di Pasquale used the ALL-TEST PRO On-Line II™ energized motor testing instrument to test the fan motor and discovered significant current imbalance at the VFD input and output (see Figure 1 and 2).

"Testing showed a current imbalance of 12.4% at the input of the VFD that became 74.8% at the output of the VFD," explains Di Pasquale. "This is not good for the motor – the VFD should supply the fan motor with balanced current. Given such high levels of current imbalance and the absence of several input half-waves, it became clear to me that the motor and fan were fine, but that the VFD needed to be replaced."

Di Pasquale discussed the issue with the owner of the facility. He explained that this current imbalance was likely a result of an internal problem with the VFD and recommended the VFD be replaced. Even though the fan could operate with this VFD-driven motor, the motor would eventually become damaged as a result of the current imbalance.

Trusting Di Pasquale's recommendation, the paint producer had the VFD removed and confirmed that there had been serious damage to the VFD's internal diodes. The paint producer ordered a new VFD and was able to maintain production while waiting for the new inverter, which took 10 days to arrive. After the new VFD was installed, Di Pasquale went back to the facility to test the fan motor with the new VFD. The second round of energized motor testing with the ATPOL II™ showed healthy waveforms (Figure 3 & 4).

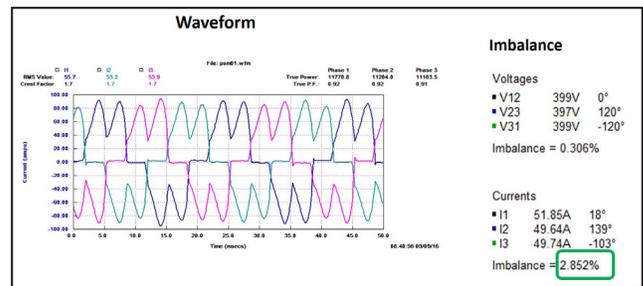
Figure 3. VFD input measurement following replacement.

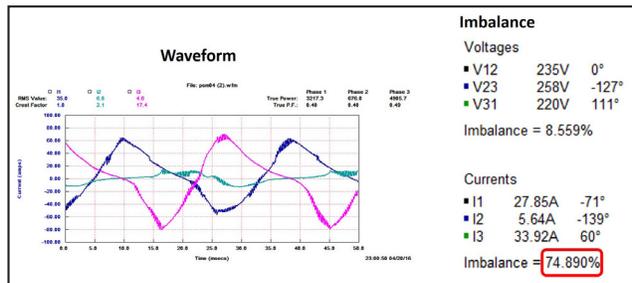
Figure 2. Measurements taken at the VFD output show significant imbalance that exists in the current fed to the motor. As you can see, the green waveform (phase 2) should be similar in shape to the blue (phase 1) and pink (phase 3) waveforms, but it is drastically different. This waveform is not normal for a healthy VFD (a normal waveform at VFD output should look like the waveform in Figure 4).

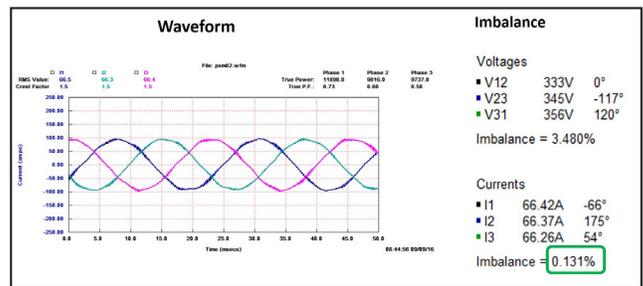
Figure 4. Output measurement of new VFD (all three current waveforms are normal).
