## CASE STUDY: Electrical Signature Analysis for Power Plant Pump Performance Assessment

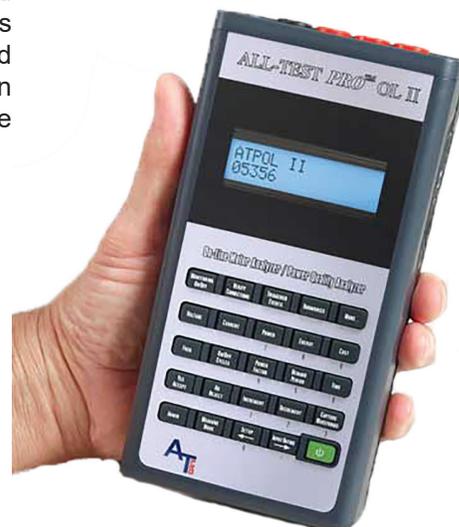
***“The ATPOL II™ collected & transmitted the data via Bluetooth while Dunn & the Maintenance team were positioned a safe distance away from the high voltage equipment.”***
