CASE STUDY:

Don't Let Vibration Data Mislead You. Perform Electrical Signature Analysis Alongside Vibration Analysis to Diagnose Motor Problems.

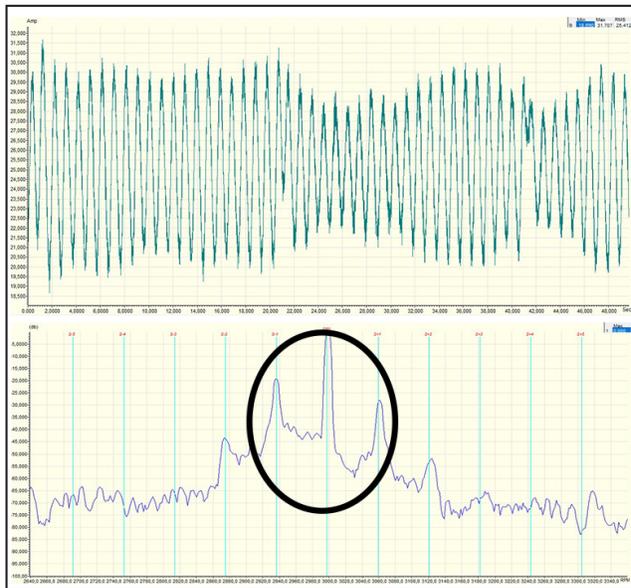
Electrical Signature Analysis (ESA) is a diagnostic technology that uses the motors supply voltage and operating current to identify existing and developing faults in the entire motor system. When in ESA mode, the ATPOL II™ evaluates the condition of incoming power, the control circuit, the motor itself, and the driven load. The ESA of this induction motor showed significant variations in current when the motor speeds up, it draws more current; when it slows down, it draws less current. The large fluctuations in current varied about 30% because the motor was varying load due to speed variations speed.

The Field Engineer reviewed his comprehensive analysis with the paper manufacturer's predictive maintenance and reliability manager, and the suggestion was made to replace the motor. A new motor was promptly installed during a planned shutdown, and another vibration analysis was performed on the new motor to make sure it was working as intended.

Vibration analysis of the new motor showed that the vibration had significantly decreased. Where the original damaged motor had shown high values of vibration around 11 mm/sec., the vibration analysis of the new motor showed values around 0.35 (30x less vibration).
