## CASE STUDY:

### Can Steel Mills Save \$7 Million a Day Through Energized Motor Testing?

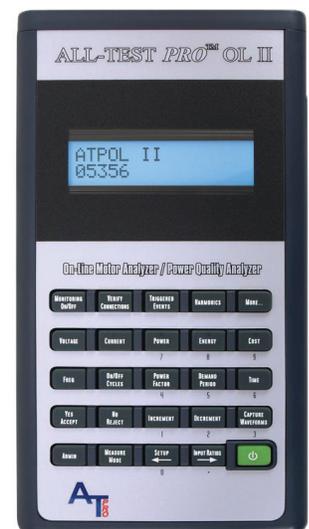
Settles connected the portable, hand-held ATPOL II™ energized motor testing instrument to the electrical panel in order to conduct the condition monitoring tests at a safe distance from the operating motor. “When I tested this 100HP motor, the ATPOL II™ indicated there was an issue with the rotor bars,” states Settles.

**“When I tested this 100HP motor, the ATPOL II™ indicated there was an issue with the rotor bars”.**

The abnormal indications were reported to the department head of the #3 coil strip, and immediate action was taken to replace the motor. Once a new motor was installed in the #3 Continuous Annealing Line, the motor with questionable health was then sent to a Midwestern motor repair facility for further inspection and analysis. The steel mill’s maintenance manager wanted the motor repair facility to check the condition of the motor and confirm the results of the energized motor test.

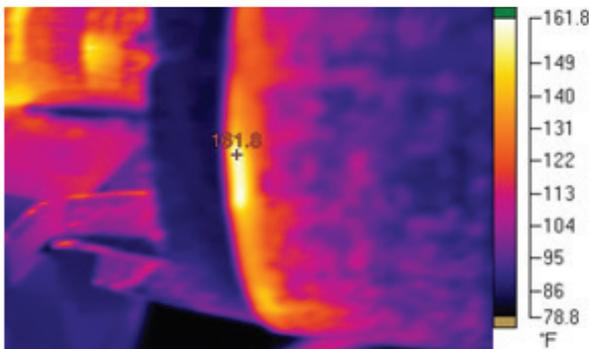
At the motor repair facility, several tests were performed: the 100HP motor showed initial Meg-ohm readings of 200+ at 500-Volts; the surge test was acceptable. Then the rotor was core-tested to look for shorts in the laminations as well as shorts in the connections between the laminations and the grounding ring.

“A hot spot was discovered in the laminations near the short circuiting ring,” explains Jonathan Walma at Harrison Electric, Inc. “The rotor bars have current induced into them from the stator to create a magnetic field. When one of these bars is disconnected, the horsepower that the motor provides is reduced and the current required to operate the motor at full loads increases, so it was a good pull; otherwise the motor would have put itself in an overload situation.”

*The infrared pictured above shows the hot spot discovered during the core test.*

After the motor repair shop confirmed the rotor issues initially detected by the ATPOL II™, the steel mill's maintenance manager compared the cost to repair the motor with the cost to purchase a brand new motor. Seeing that the cost to repair the motor was greater than the cost of a new motor, the maintenance manager requested the faulty motor be returned to the steel mill for proper recycling and disposal.
