## CASE STUDY:

### Predictive Maintenance Team Saves Steel Mill Time and Money with Thorough Motor Testing

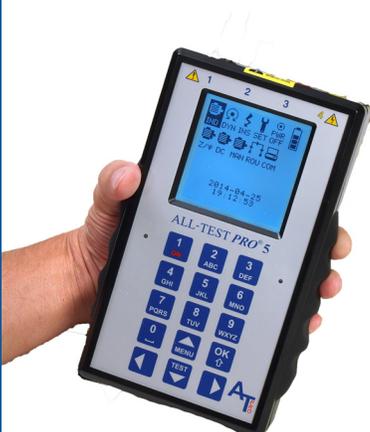
The AT5™ was connected to the motor control panel and a Motor Circuit Analysis™ was performed on the 20-horsepower trolley motor. Within only a few minutes time, the test results showed a disconcerting insulation-to-ground

readout of 10.1 Meg-ohms (see Figure 1).

32	21	13	
Resistance (Ohm)	OK	0.840	0.836	0.831	0.580
Impedance (ohm)		11.1	11.2	11.2	0.876
Inductance (mH)		8.78	8.90	8.90	0.884
Phase Angle (°)	OK	75.6	75.4	75.5	0.0750
I/F (%)	OK	-46.2	-46.0	-46.1	0.0936
Stator					
Rotor					
Insulation (MOhm)	WARN 10.1				
				TVS	18.6
				Ref Value	
Contamination (%)	NA				
Capacitance (nF)	NA			Frequency	200

*Figure 1. Results from AT5™ motor testing instrument; from Motor Circuit Analysis™ performed at motor control panel on March 6th, 2017.*

This 'practically new' motor, which had been installed onto the crane in October of 2016, was tested at the time of its initial installation. That very first test had shown a reading of greater than >999 Meg-ohms. This difference in test results raised some red flags for the predictive maintenance team. Seeing as how the motor had only been in operation for six months, it was clear that the motor should not have deteriorated that quickly.
