CASE STUDY:

Loose Power Connections

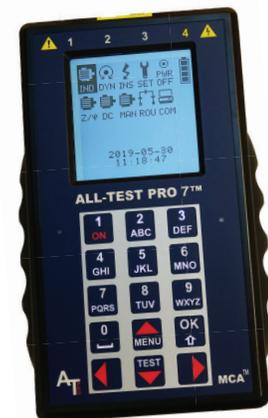
Figure 1 Initial Report from MCC

An initial review of the MCA™ software report titled “equipment to review,” identified all machines that were in alarm. The report noted an unbalance in resistance and phase angle for a particular conveyor motor (see Figure 1).

32	21	13		
Resistance (Ohm)	BAD 4.49	0.554	5.89	BAD 34.8	
Impedance (Ohm)	45.9	54.0	63.3	36.7	
Inductance (mH)	72.2	86.0	132	36.7	
Phase Angle (°)	BAD 71.9	83.8	73.5	7.32	
1/F (%)	OK	-42.8	-42.3	-43.1	0.454
Stator					
Rotor					
Insulation (MOhm)	OK	>5000		TUVS 183	
Contamination(%)	OK	1.69%		Ref Value	
Capacitance (nF)		4.35		Frequency 100

Findings: Check for loose connections.
Shorted Stator Winding. Repeat the test to confirm.
Recommend performing rotor compensated winding test. See manual for details.
Recommend check at motor if tested from MCC.
Insulation Test Voltage: 500V
Instrument: AT701566
Calibration: 20191015-11:25

The resistance unbalance indicated a possible loose connection. The phase angle unbalance indicates a developing phase to phase short. Based on the findings' recommendations provided by the MCA™ analysis report (see Figure 2), the tech tested directly at the motor conduit box. The tech found no visible issues upon his initial inspection of the wiring. Next, the tech proceeded to unwire the motor from the building supply wiring and retested the motor wiring only. This test indicated an "OK" condition for resistance and phase angle on the screen of the ALL-TEST PRO 7™ testing device.

The tech determined that the issue could have been a loose wiring connection issue in the motor conduit box. To confirm this theory, the tech reconnected the building supply wiring to the motor properly and retested at the motor disconnect. Again, this test indicated an "OK" condition for resistance and phase angle on the screen of the ALL-TEST PRO 7™ testing device. This confirmed the wiring connection at the motor conduit box was this issue and was corrected by rewiring the building supply connections. Figure 3 below is the uploaded MCA™ analysis report of the successful test at the disconnect. This test shows the motor resistance and phase angle are in a balanced condition and registering an "OK" operating condition.
