## CASE STUDY:

### Energized Motor Testing Reveals Improper VFD Settings

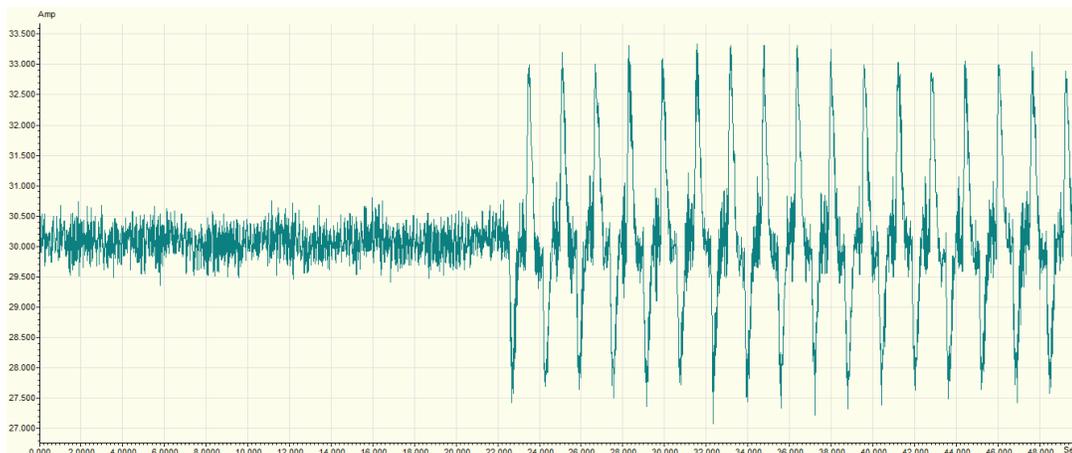
*Figure 1. Results of initial test show the current waveform. There is evidence of strong load fluctuations (peak 6 amps at 20% of the total load). These fluctuations were determined to be caused by improper configuration of the VFD controller and its PID.*

**“While there was no visible cause for alarm, the motor testing showed evidence of strong load fluctuations,” explains Di Pasquale. “Load fluctuations can occur when a VFD asks a motor to continuously change speed, even when a change in speed is not really required for the motor to perform its intended function.”**

Di Pasquale discussed the issue with the managers at the food packaging printing plant. He explained that when a VFD asks a motor to continuously change speed, that this activity can put a lot of stress on the motor mechanics and the motor windings. If the VFD continued to vary the motor speed in this way, over time the motor could have eventually exhibited rotor problems or winding failure.

To prevent motor failure, Di Pasquale suggested the VFD be checked. Trusting Di Pasquale’s recommendation, the maintenance managers at the food packaging printing plant contacted the VFD supplier. The VFD supplier went on-site to re-program the VFD, adjusting it to correctly drive the motor.

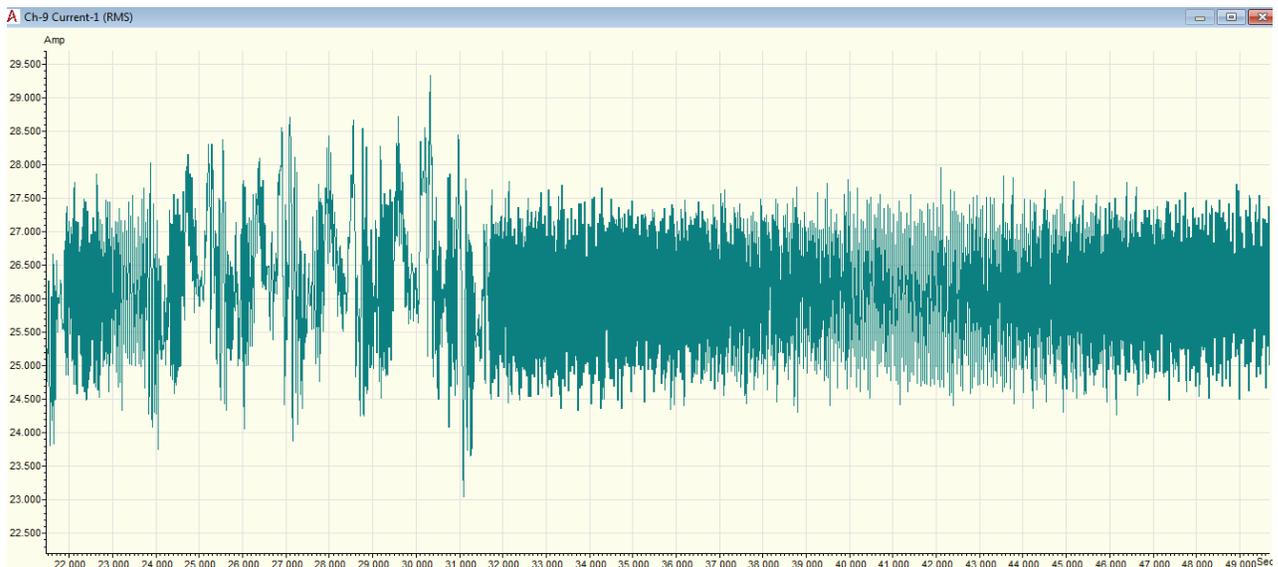
The second round of energized motor testing with the ATPOL II™ showed the load performance had been greatly improved after the VFD reconfiguration / PID correction (see Figure 2). Testing proved the VFD supplier correctly re-programmed the VFD to drive the motor.

*Figure 2. Energized motor testing with the ATPOL II™ shows the load performance is greatly improved after the VFD reconfiguration / PID correction.*

After the VFD supplier re-programmed the VFD, Di Pasquale went back to the food packaging printing facility to perform a follow-up energized motor test. He wanted to make sure there were no more load fluctuations or abnormal waveforms. He again brought the ATPOL II™ to confirm that the problem had been corrected.
