“Motor Testing” Which Road Will You Take?

Dave Humphrey
Allison Transmission
Indianapolis, IN

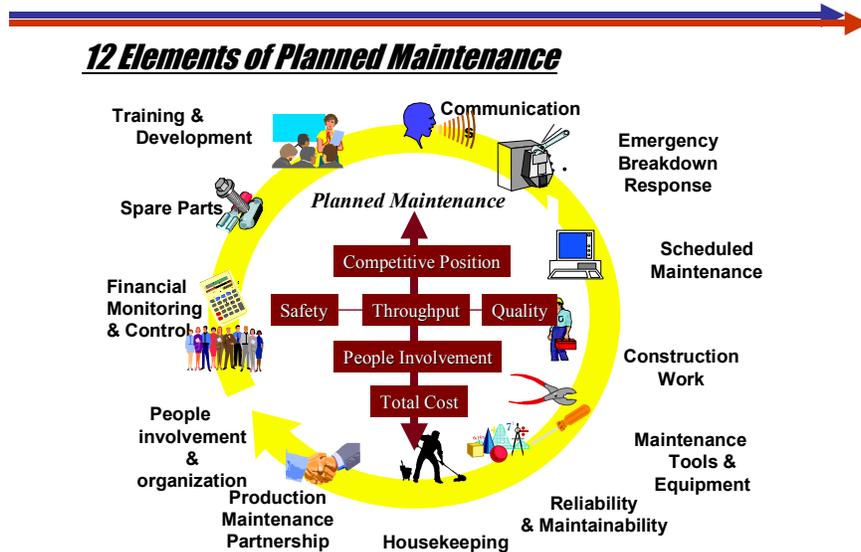
Figure 1: Planned Maintenance Process

There are twelve interdependent elements in planned maintenance that are integral to a successful process. Each element contributes to and provides support for the others. The linked elements, in total, provide the base for the Planned Maintenance Process (Figure 1):

- ✓ People Involvement and Organization
- ✓ Financial Monitoring and Control
- ✓ Spare Parts Availability
- ✓ Training
- ✓ Communications
- ✓ Emergency Breakdown Response
- ✓ Scheduled Maintenance
- ✓ Construction Work
- ✓ Maintenance Tools and Equipment Availability
- ✓ Reliability and Maintainability
- ✓ Housekeeping and Cleaning
- ✓ Production Maintenance Partnership

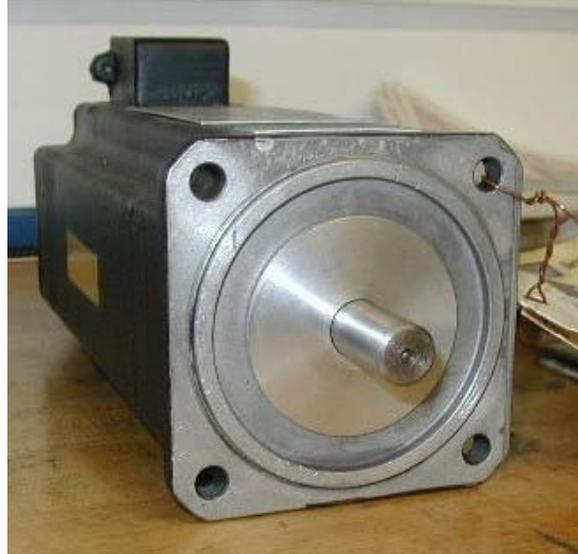
Figure 3: Servo Motor

In one department, a servomotor had failed seventeen times in ten months. The supplier was called in to assist in determining a root cause and a corrective action plan. The motor was in a wet harsh area that had a lot of coolant fluid. The vendor suggested a slinger on the motor shaft and a special seal process to keep the motors from prematurely failing. The company's motor supplier identified these modifications with a yellow stripe to indicate the motor was modified (Figure 3). To date the servomotor has not had another winding failure due to contamination.

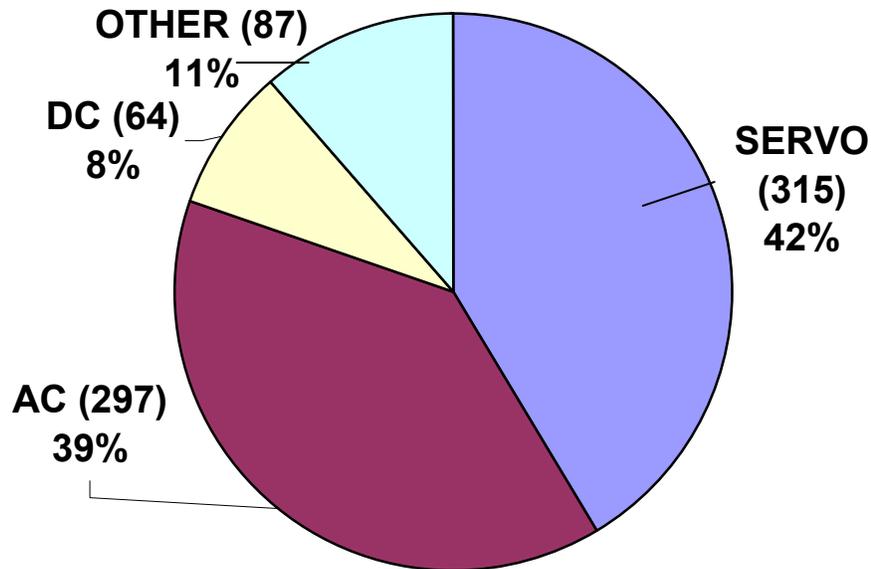
Figure 5: Motor Failures in 2002

Allison Transmission's motor program is a crucial component within operations. With MCA motors that have problems can be tested to confirm the fault, before being removed and sent out for repair. If a motor problem is not found, the electrician helps the service technician find a root cause. Motors that are difficult to install are tested prior to calling machine repair personnel for installation. Motors in the supplier's warehouse are audited on a quarterly basis with an MCA test. Some routes have been established due to repetitive motor failures, these motors are tested and trended monthly as part of the MCA process. Motors with pumps are tested prior to rebuilding the pump in order to determine if the motor pump combination may be more economical to replace than to rebuild. The breakdown of the different types of motors repaired or replaced during 2002 can be seen in Figure 4.

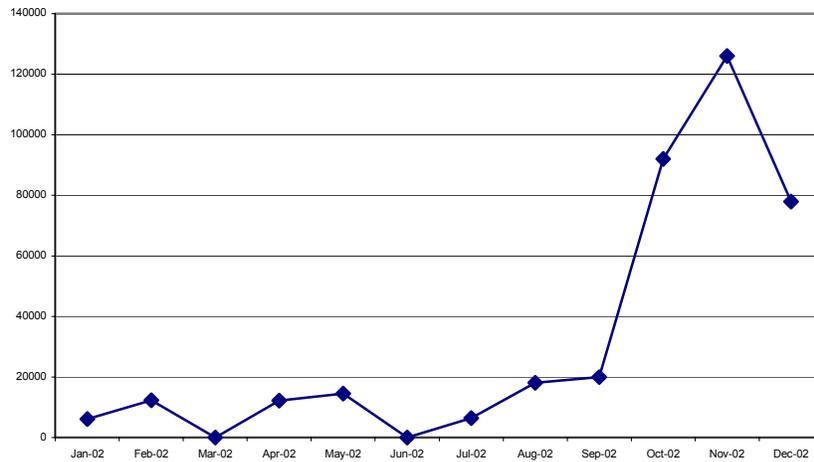
Figure 6: MCA Cost Avoidance for 2002

Allison Transmission prefers proactive vs. reactive maintenance particularly from a financial perspective. For instance, the total cost savings avoidance at Allison attributable to the MCA program in 2002 was \$307,664 (Figure 6).
